REVEGETATION AND SELECTED TERRAIN DISTURBANCES ALONG  
THE TRANS-ALASKA PIPELINE 1975-1978(U) COLD REGIONS  
RESEARCH AND ENGINEERING LAB HANOVER NH L A JOHNSON  
JUN 81 CRREL-81-12 F/G 6/6

## *Revegetation and selected terrain disturbances along the trans-Alaska pipeline, 1975-1978*

Lawrence A. Johnson

June 1981

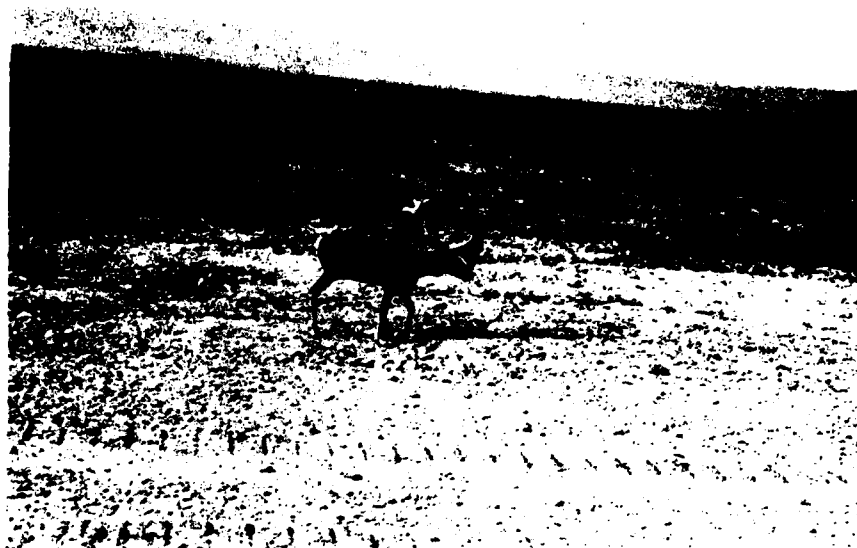
Figure 15. Caribou grazing on revegetated workpad, 14 August 1978.

13. *Animal grazing.* Various populations of native mammals and birds have been observed grazing upon revegetated areas. They included microtines at numerous locations, caribou north of Toolik (Fig. 15) and especially at site 127J1, dall sheep along the workpad near Galbraith Camp, bison at AS 42 and moose in the Interior (Fig. 16). Birds such as ptarmigan and migratory waterfowl extensively grazed on revegetated areas north of Toolik. Presumably these animals were attracted by factors such as the delayed senescence of introduced species and the higher nutrient content of vegetation within the fertilized areas.

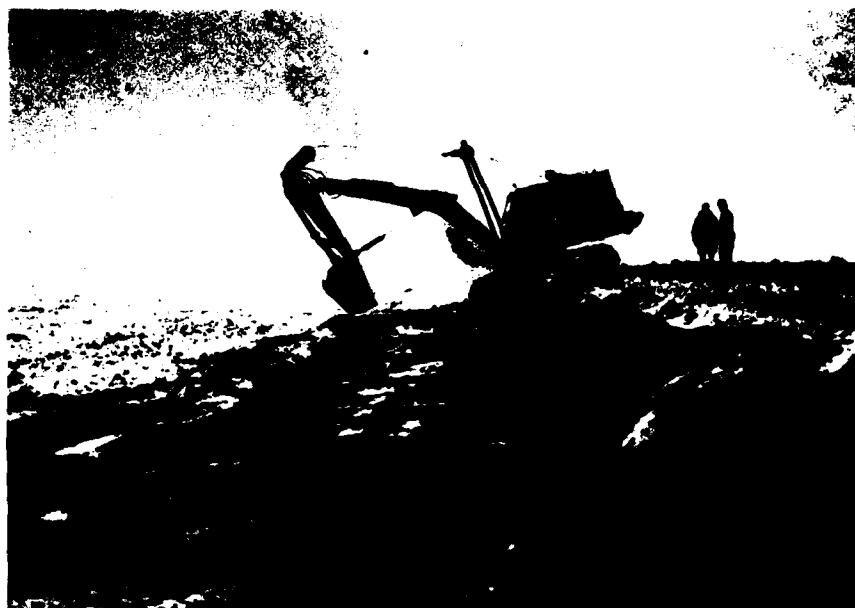
*Figure 39. Backhoe operating from highway scraping debris from snowpad, 26 May 1976.*

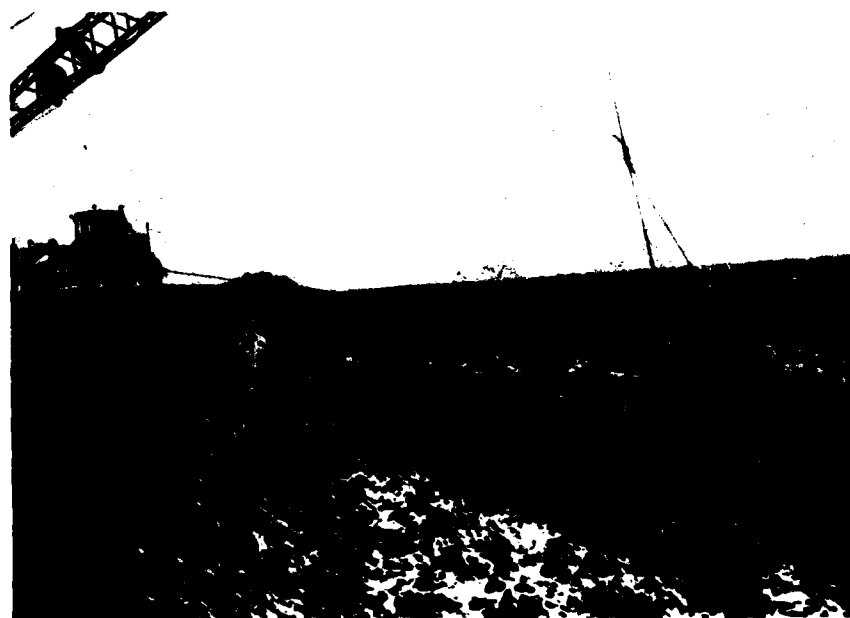
*Figure 40. Crane with bucket scraping debris from snowpad, 26 May 1976.*

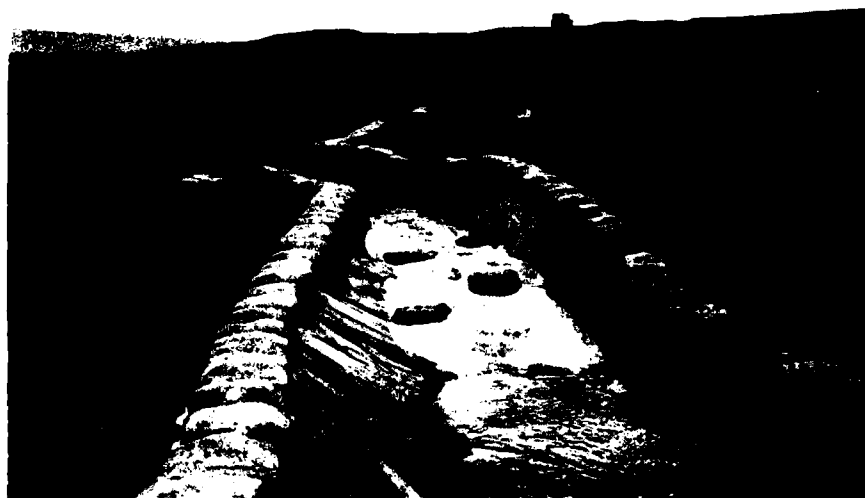
*Figure 42. Half culvert in background adjacent to road culvert and lined ditch channel downslope from the fuel gas line (photograph by J. Brown).*

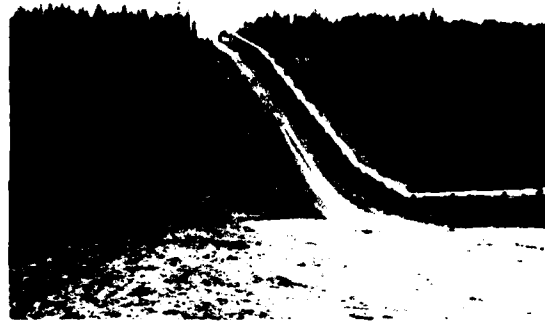
b. September 1976 (70, 10, 65).

Figure B9. Site 19J1, Klutina River cut beside workpad. Heavily mulched with straw (25–45 cm) to stabilize ice-rich soils (1975), erosion gullies, spruce at base of hill dying from eroded silt (1976), logs and plastic-lined ditches to stabilize workpad (1977), area stable (1978). Native species: lamb's-quarters, fireweed, squirreltail and alder.

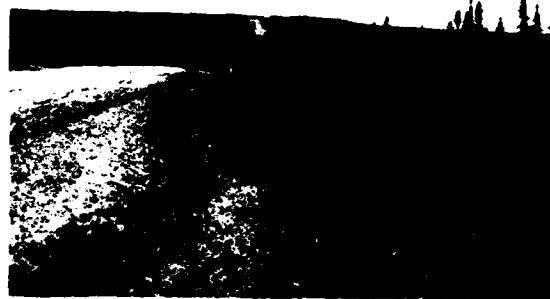
Figure B36. Site 91J1, material site 91-3. Probably seeded in 1974. Organics mixed with weathered granite, vascular plant cover increased, but still low and discontinuous, moss cover 50% (1978). Native species: fireweed, willows, balsam poplar, sedge, yarrow and birch.

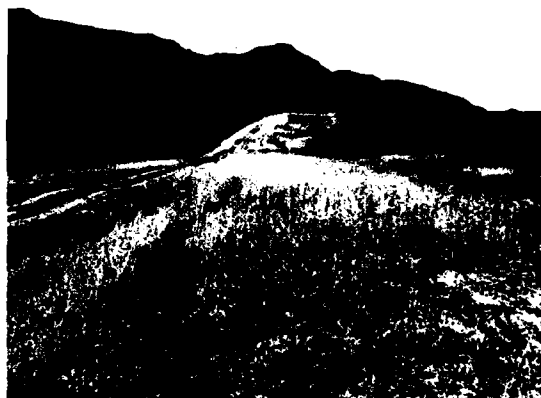
Figure B51. Site 110J1, road cut covered with plastic-backed excelsior mesh. Seeded (1975), melting behind road cut (1976), growth still reduced (1977), detached clumps of native vegetation re-establishing over mesh (1978). Native species: coltsfoot, cottongrass, sedges and tall arcticgrass.
